Why Things Break

Henry Petroski

Metal fatigue has long posed a challenge to engineers

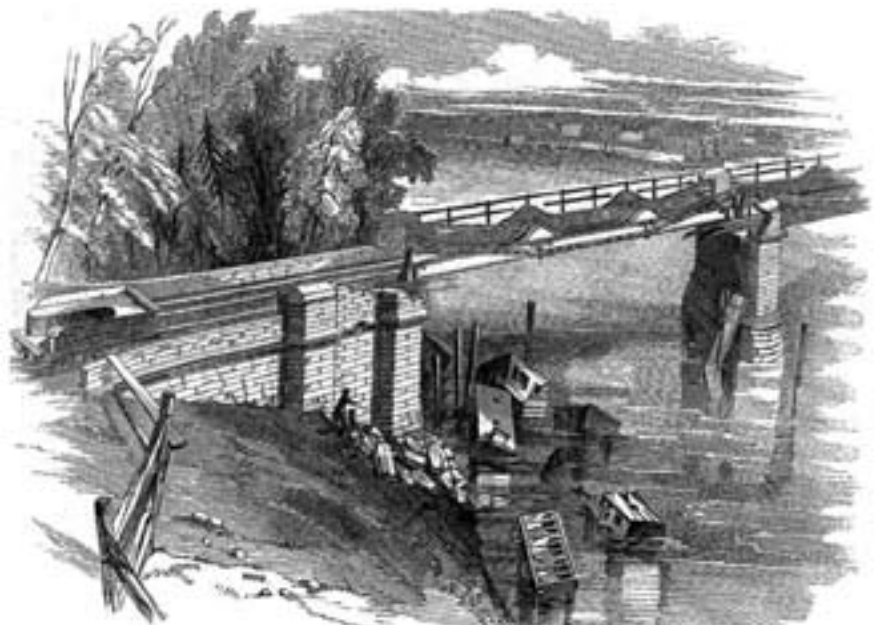
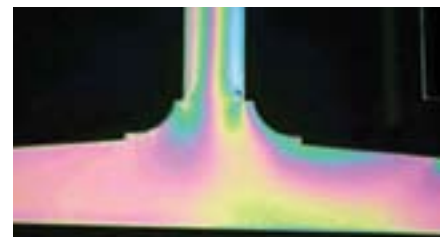
Dee Bridge, at Chester, England, collapsed in 1847 as a train passed over it. Five people were killed. Peter Lewis, of the Open University, thinks that stress concentration at an ornamental cavetto molding (see simulation, at right) led to fatigue-crack growth and ultimately failure of a cast-iron beam. (Image at top from the *Illustrated London News*; simulation courtesy of Peter Lewis.)

The scenario that Lewis imagines for the Dee Bridge is as follows. The iron beams were cast with a detail known as a cavetto molding at the location where the vertical web met the horizontal bottom flange. Similar moldings were and are familiar finishing details where vertical walls meet horizontal ceilings in a house. Since carpenters would likely have been involved in making the forms for the cast-iron girders, they may well have introduced the detail as a finishing flourish, perhaps even thinking that it would produce not only a better looking beam but also a better-performing one. Unfortunately, the sharp corners of the cavetto molding provided a site for concentrating stress (much as a crevice provides one for collecting dust). If the cast beam contained any flaw at all—such as a tiny void, nick or other imperfection—it could serve as a nucleation site for a crack to grow a small amount with each passing train, a phenomenon known as fatigue-crack growth. In time, the crack

would reach dangerous proportions, and the next time the beam was loaded with a passing train it would give way. Thus Lewis hypothesizes that the Dee Bridge failed because of metal fatigue initiated at the aesthetic flourish. Making things prettier should not come at the expense of making them stronger.

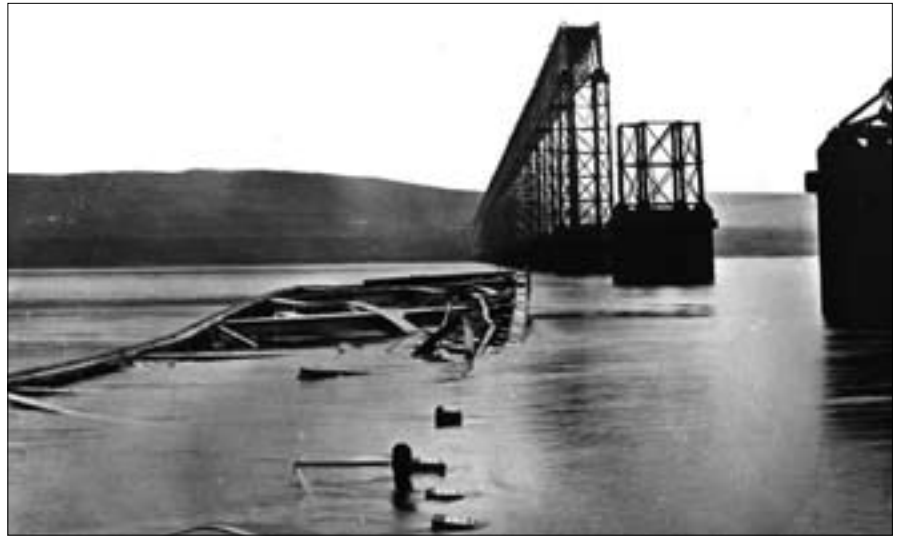
What he found in the photos were fractured wrought-iron bolts and broken pieces of cast iron that were identified as parts of the lugs that had been cast integrally with the columns designed to support the weight of the high girders. Lewis also found evidence in the photographs that the bolt holes were not drilled out but rather were cast directly into the lugs. Drilling would have left cylindrical holes, which would have provided relatively long parallel bearing surfaces for the bolts; the casting process left tapered holes in the lugs, thereby setting up a condition in which the bolts fit loosely and the force exerted on each lug was concentrated on a smaller surface, thereby increasing the stresses in the lug. Elevated stresses, applied each time a train passed over the bridge, accelerated the growth of any cracks that might have developed in the lugs, and when the cracks reached a critical size, the lugs failed. In other words, they failed after fatigue-crack growth. Some of the photographs confirmed this by showing characteristic patterns of incremental crack growth on the fractured surfaces.

Tay Bridge, at Dundee, Scotland, was also ultimately a victim of metal fatigue in cast iron, according to Peter Lewis. It collapsed in 1879, claiming 75 lives. (Photograph courtesy of Peter Lewis.)

numerous broken lugs suggests that over time much of the bracing had been lost in the support towers, rendering them more flexible and prone to a racking motion in a direction transverse to the bridge. Such flexibility would likely have increased as the structure aged, with more and more lugs fracturing and thus providing no support for the tie rods. The vibrations set up by passing trains drove the growth of fatigue cracks and the consequent failure of lugs, which in turn led to larger vibrations, which sped up the deterioration of the structure. The combination of a fast, heavy train crossing the bridge in a strong wind must have caused the towers and high girders to deflect sideways to the point of no return.
