VANITIES OF THE BONFIRE

Henry Petroski

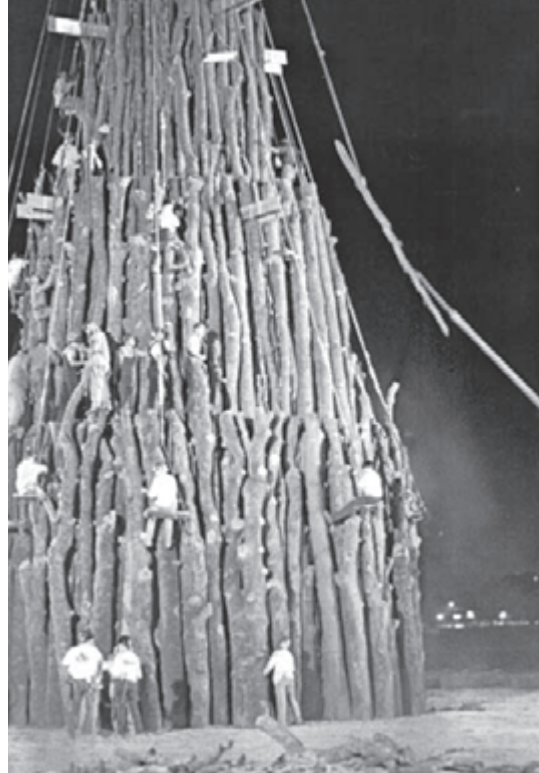
Figure 1. Bonfire is an 90-year-old tradition at Texas A&M University. (Photograph courtesy of the Bonfire Special Commission.)

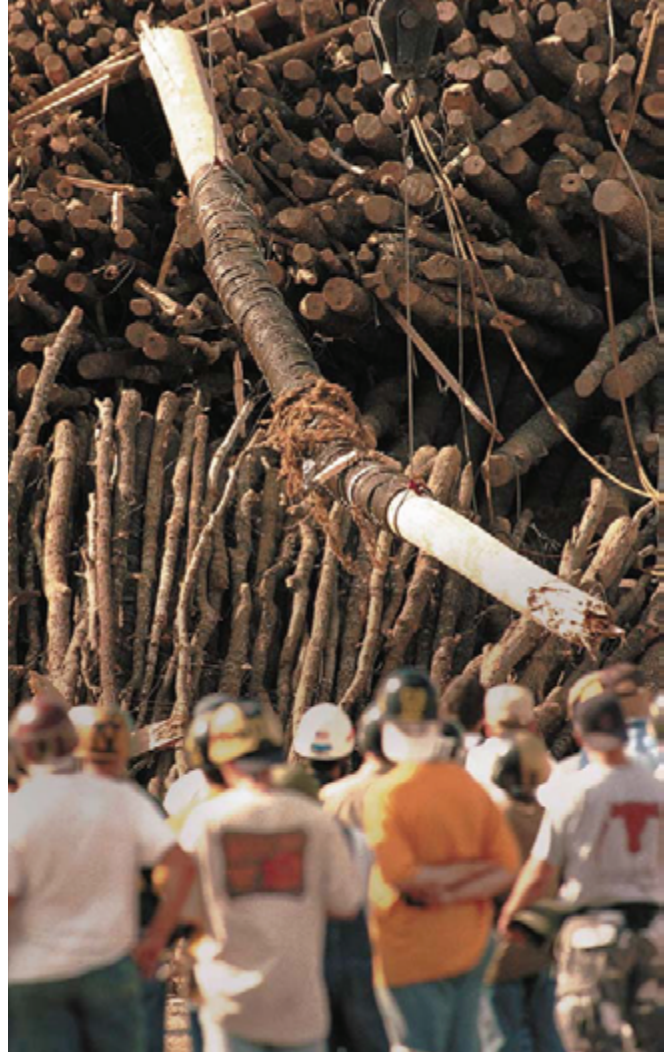
Figure 2. Bonfire’s central pole, although broken in the collapse, was not the cause of the accident. (Photograph courtesy of Butch Ireland, the Bryan-College Station Eagle.)
