American Scientist

ST. FRANCIS DAM

Henry Petroski

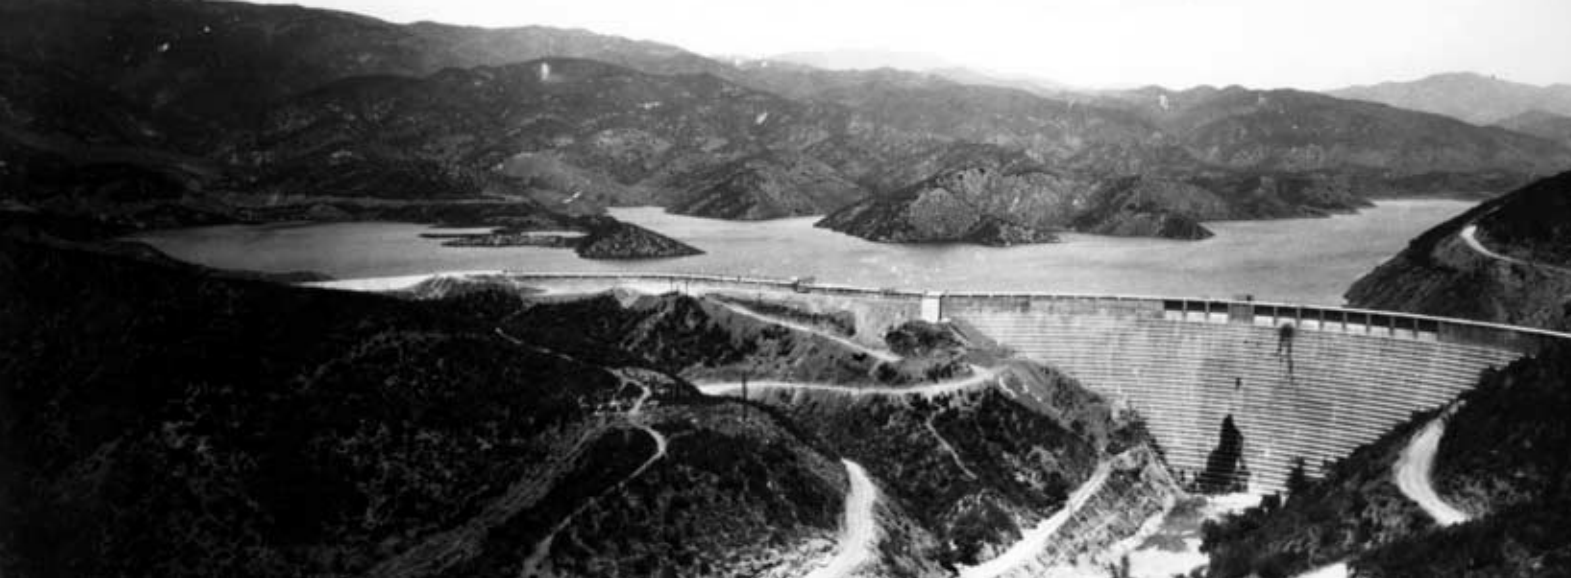
Figure 1. St. Francis dam impounded 38,000 acre-feet of water prior to its failure on March 12, 1928. (Photograph by the Los Angeles Department of Water and Power.)

St. Francis Dam was similarly designed to be made of concrete, because there was no suitable clay or silt available at the San Francisquito Canyon site. The new dam would also be a stepped concrete gravity arch structure: Its downstream face was constructed like a wide set of steps, its material was mass (unreinforced) concrete, and the structural principle by which it held back the water was through its sheer weight pressing down on the ground, aided by an arched plan that took advantage of the water pressure behind it to compress or wedge the dam between the sides of the canyon, which served as abutments.

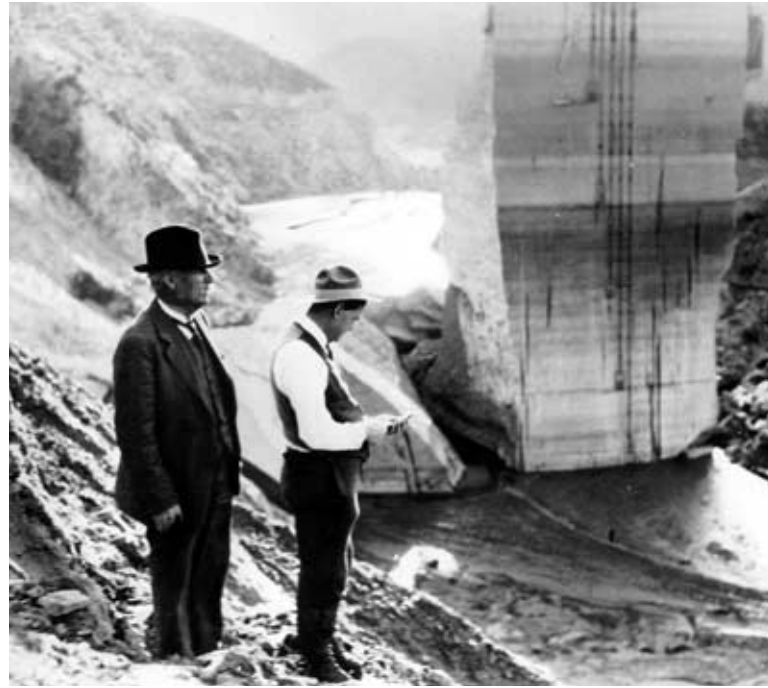
Figure 2. William Mulholland (left) views the remains of St. Francis dam. (Photograph courtesy of the Wilkman Productions Collection.)

A little before midnight that same day, the dam gave way and the contents of the reservoir inundated San Francisquito Canyon. The water rushed down the canyon, destroying everything in its path. Some large sections of the concrete dam, weighing thousands of tons, were washed as much as a mile downstream, leaving only the tall center section of the structure remaining in place, with some other large blocks scattered nearby, mostly between the center section and what was the east abutment. A powerhouse located about a mile and a half downstream was washed away, as were a construction camp and houses in little towns and villages in the path of the water. Hundreds of people were killed, most no doubt unsuspecting as they slept. The official death toll was in excess of 430, but the actual total is debated to this day.
