A reprint from
American Scientist
the magazine of Sigma Xi, The Scientific Research Society

PAST AND FUTURE FAILURES

Henry Petroski

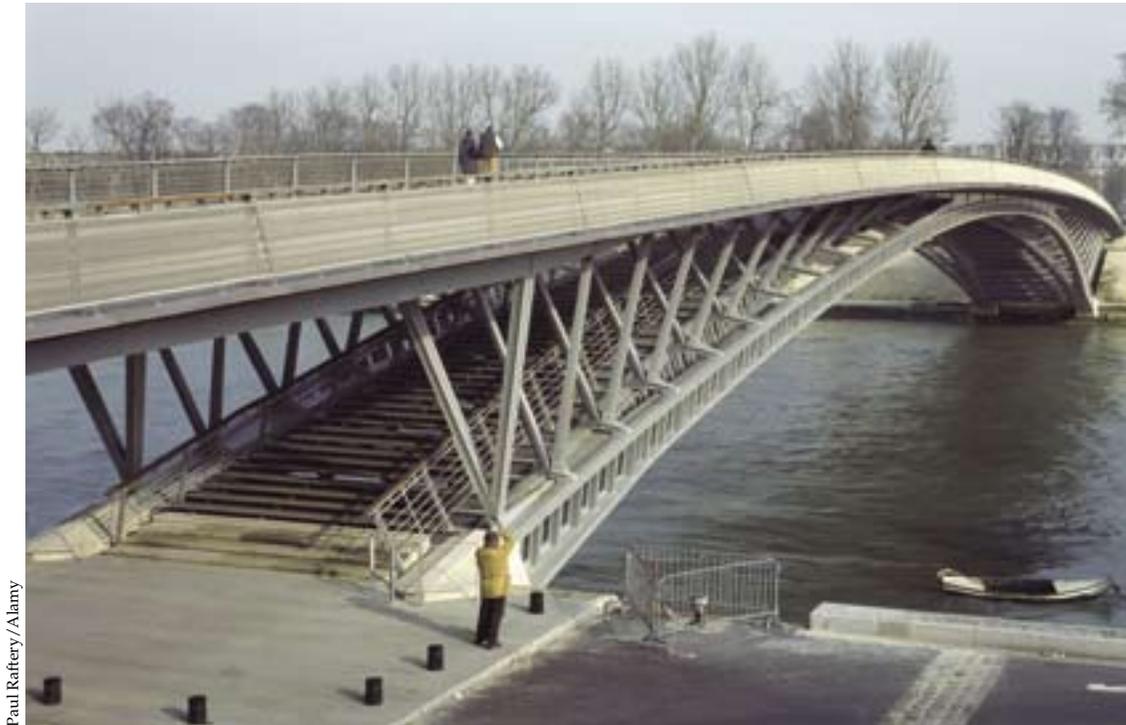
Figure 1. Since the collapse of the Dee Bridge in 1847, bridge failures appear to recur at approximately 30-year intervals. This suggests that a failure should have been due around the year 2000, 30 years after the Milford Haven Bridge collapsed during construction. Although no bridge fell at the changing of the millennium, several footbridges exhibited severe problems, including this one, the Passerelle Solferino in Paris.

The London Millennium Bridge is, of course, famous for having been shut down just three days after its opening in June 2000, when the bridge started swaying sideways to an alarming degree ("Millennium Legacies," September–October 2001). A similar thing had happened the prior year to a footbridge in Paris. The Passerelle Solferino was designed to give pedestrians a peaceful crossing of the Seine from the Tuileries quay to the Musée d'Orsay. Although tested before opening with 150 people dancing to a beat designed to reveal dynamic susceptibilities, this technologically innovative arch bridge swayed on opening day. The 2-centimeter movement, amplified by French politics, forced the closure of the bridge that same day. Its architect-engineer, Marc Mimram, admitted that designing a footbridge "is more difficult than other bridges, with its conflicting demands of light weight and long span." Still, how could such embarrassing oversights happen, on the eve of the 21st century, when engineers were using powerful computers to design what their ancestors once sketched out only with sticks in the sand?

As with the bridge types Sibly studied, the design of footbridges had become routine. The loads considered did not include the sideways forces exerted by people walking, which have a frequency of one-half that of their vertical footfall. Historically, this had not been a problem, but the natural frequency of sideways motion of the Pont Solferino and London Millennium Bridge was close to what people walking in step would exert. Though crowds of people do not generally walk in step, when the bridges began to move sideways—for whatever reason—the people fell into step the better to keep their balance. This in turn magnified the sideways motion of the structure, and a positive feedback loop developed. The motions got so violent that public safety concerns dictated that the bridges be closed.

The Solferino and London Millennium bridges do not look anything like each other. The former is an arch and the latter a low-profile suspension bridge. Yet although they do not look similar, they shared the same design assumptions with all other footbridges, which clearly did not take into account the critical loading mode. In this sense the development of footbridges falls into the pattern pointed out by Sibly—namely, that the state of the art, which had developed out of successful experience, was finally being pushed, albeit inadvertently, into realms for which it was inadequate. By this criterion, the failure of these footbridges, in which dynamic phenomena insignificant in bridges of lesser magnitude revealed themselves to be limiting, fulfills the prediction

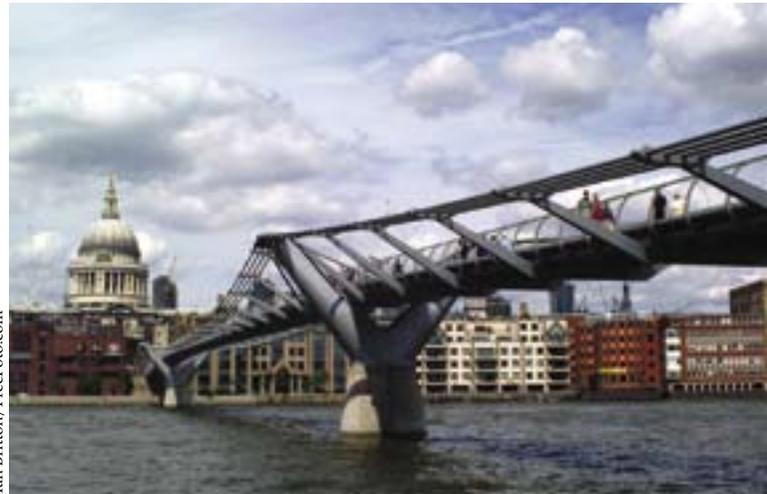
Figure 2. London's Millennium Bridge had to be closed three days after it first opened because of swaying. A retrofit solved the problem and the bridge reopened in February of 2002.
